D-1458

PRELIMINARY INVESTIGATION OF EFFECT OF HYDROGEN ON
STRESS-RUPTURE AND FATIGUE PROPERTIES OF AN
IRON-, A NICKEL-, AND A COBALT-BASE ALLOY

NATIONAL AERONAUTICS AND SPACE ADMINISTRATION
WASHINGTON

December 1962

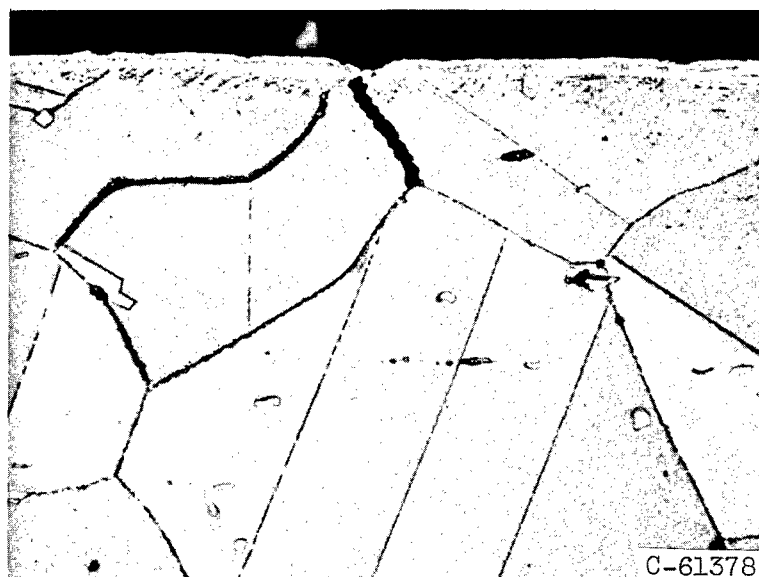
(b) Inconel 700; stress-rupture test; life, 198.3 hours.

Figure 7. - Area near region of failure of typical specimens showing internal surface after exposure to hydrogen.

Figure 7 shows photomicrographs of typical tested specimens (fatigue or stress rupture) along the surface exposed to hydrogen. The area chosen was near the point of failure in all cases. Figure 8 presents photomicrographs of additional tested specimens (fatigue or stress rupture) of each alloy along the internal surface, which show areas away from the point of failure. No scale is evident on the surface exposed to hydrogen, however, the microstructure of each of the alloys was affected to varying depths beneath the specimen internal surface. The affected zone was generally continuous through both the cracked and noncracked areas. Some depletion of alloying elements may have occurred in these zones. A-286 shows the narrowest affected zone (figs. 7(a) and 8(a)). Figure 7(c) indicates that S-816 had the widest affected zone. At a magnification of 500 only the affected zone itself is observable. Its true depth is apparent from the photomicrograph at a magnification of 250. The marked absence of precipitates in the affected zone of the S-816 specimens, both within the grains and in the grain boundary regions, suggests that this material may have been decarburized and considerably weakened by the hydrogen environment. Such a weakening effect may have contributed to the reduction in average stress-rupture life and the apparent lesser reduction in fatigue life observed with this material during the hydrogen tests. It is interesting to note that numerous cracks were observed in this affected zone (fig. 7(c)). Metallographic studies, however, did not indicate that a greater amount of cracking occurred or that fracture was preferentially initiated in these zones compared with the region adjacent to the external specimen surface.

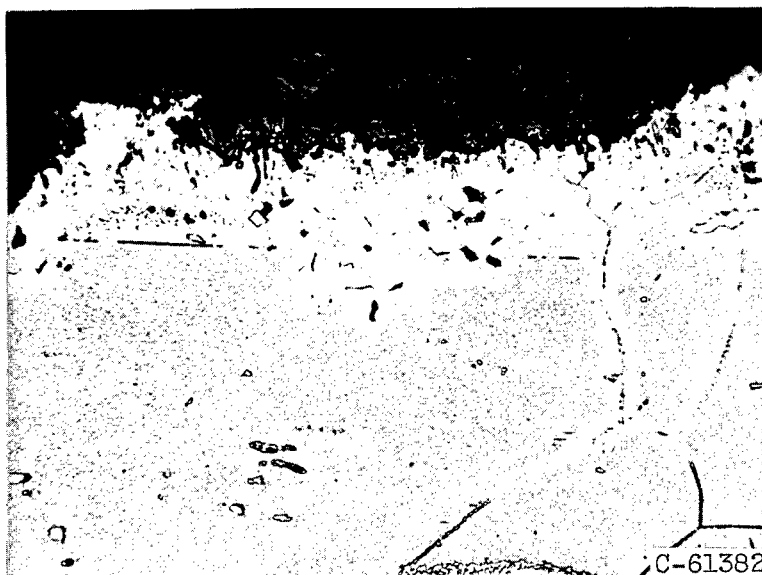
(b) Inconel 700; fatigue test; life, 83.4×10^6 cycles (705.5 hr).

Figure 9. - Continued. Typical specimens showing both internal and external surfaces in region of failure. Internal surface exposed to dried air; external surface exposed to relatively humid air. X500.

Figure 9 shows typical microstructures along both the internal and the external surfaces of specimens of each alloy after air tests in the areas near the specific points of failure. Figure 10 presents similar

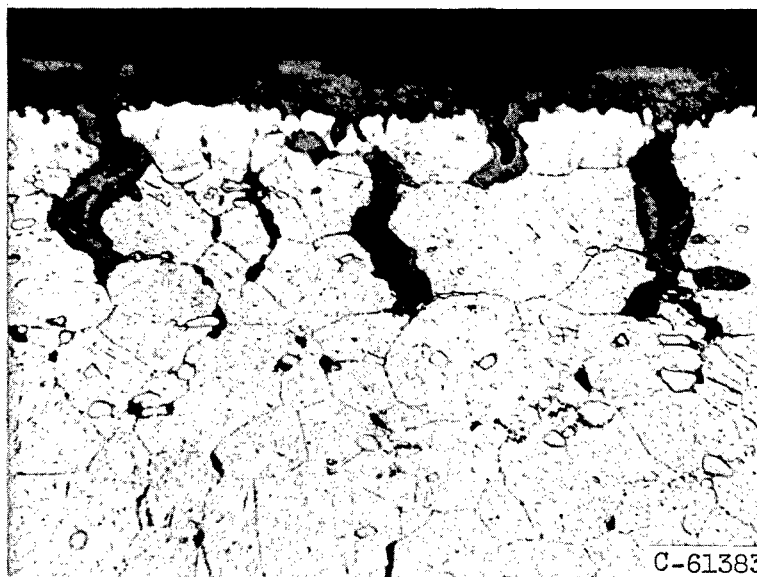
(c) S-816; stress-rupture test; life, 232.8 hours.

Figure 9. - Concluded. Typical specimens showing both internal and external surfaces in region of failure. Internal surface exposed to dried air; external surface exposed to relatively humid air. X500.

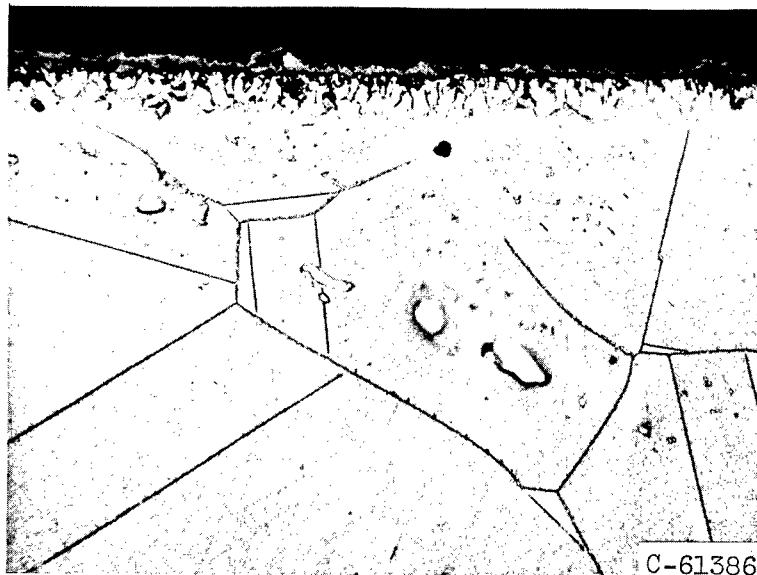
(b) Inconel 700; fatigue test; life, 47.4×10^6 cycles (401.6 hr).

Figure 10. - Continued. Typical specimens showing both internal and external surfaces in area some distance from region of failure. Internal surface exposed to dried air; external surface exposed to relatively humid air. X500.

photomicrographs of additional specimens of each alloy, which show regions away from the failure area. It is apparent from these figures that, in general, a considerably thicker scale was formed on the external surface exposed to relatively humid air rather than on the internal specimen surface exposed to dried air. This scale extended through both the cracked and uncracked areas. Microscopic examination indicated that considerable oxidation occurred in the cracks that formed near the point of failure of air-tested specimens in all the materials investigated. Oxidation occurred in the cracks that extended from the internal surface as well as those that extended from the external surface. This was most apparent in stress-rupture tested specimens and is best illustrated in figure 9(c). No oxidation occurred in the cracks that extended from the internal surfaces of specimens exposed to hydrogen.]
